Technical Note N-1263

EFFECT OF BOTTOM SEDIMENT CONTAINING  
HYDROGEN SULFIDE ON MATERIALS - PART I

NAVAL CIVIL ENGINEERING LABORATORY  
Port Hueneme, California 93043

ABSTRACT

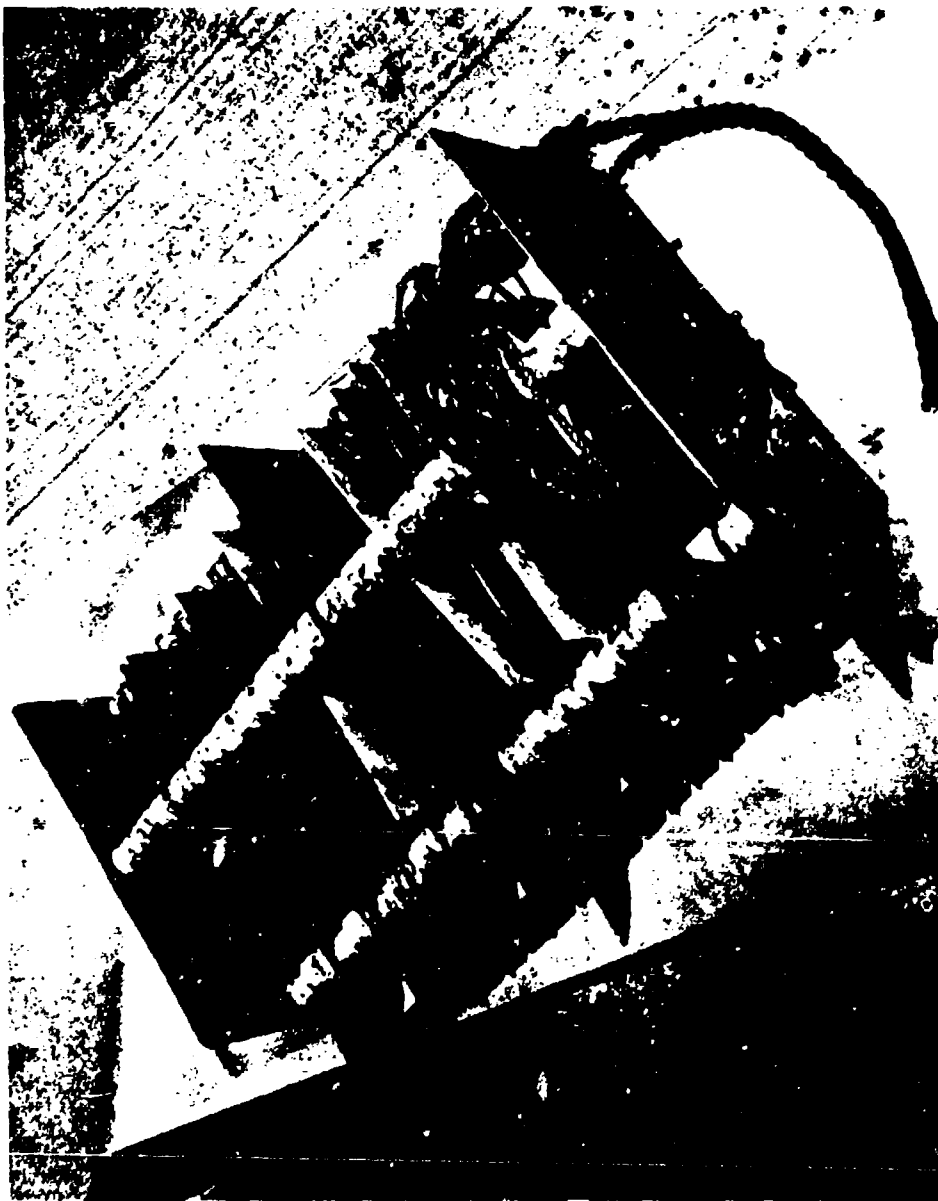
The titanium rack with materials which has been exposed in the bottom sediment for a period of one year was recovered by divers during the month of September 1972 (Figure 4). The depth into which the materials were buried in the sediment can be determined by the end plate of the titanium rack (Figure 5). There was light fouling growth attached to the recovered materials. The sessile organisms found attached to the materials were composed mostly of encrusting bryozoa (several species), calcareous tubeworms, and rock oysters. These fouling organisms are not adversely affected by living in a seawater environment containing hydrogen sulfide and low dissolved oxygen concentration. After the plastic panels (6 x 12 inch) were cleaned of marine growth, hardness and moisture absorption tests were conducted. The results of these tests are presented in Table 1. The hardness test was conducted over two different sections of the surface of the plastic panels - the section which was buried in the mud and the section which was exposed to seawater above the mudline. The two sections would be distinguished by the discoloration present in the plastic panel. For example, the section of a PVC panel (grey)

Figure 4. Titanium rack with materials recovered after one year exposed (partially) in bottom sediment of Port Hueneme Harbor.

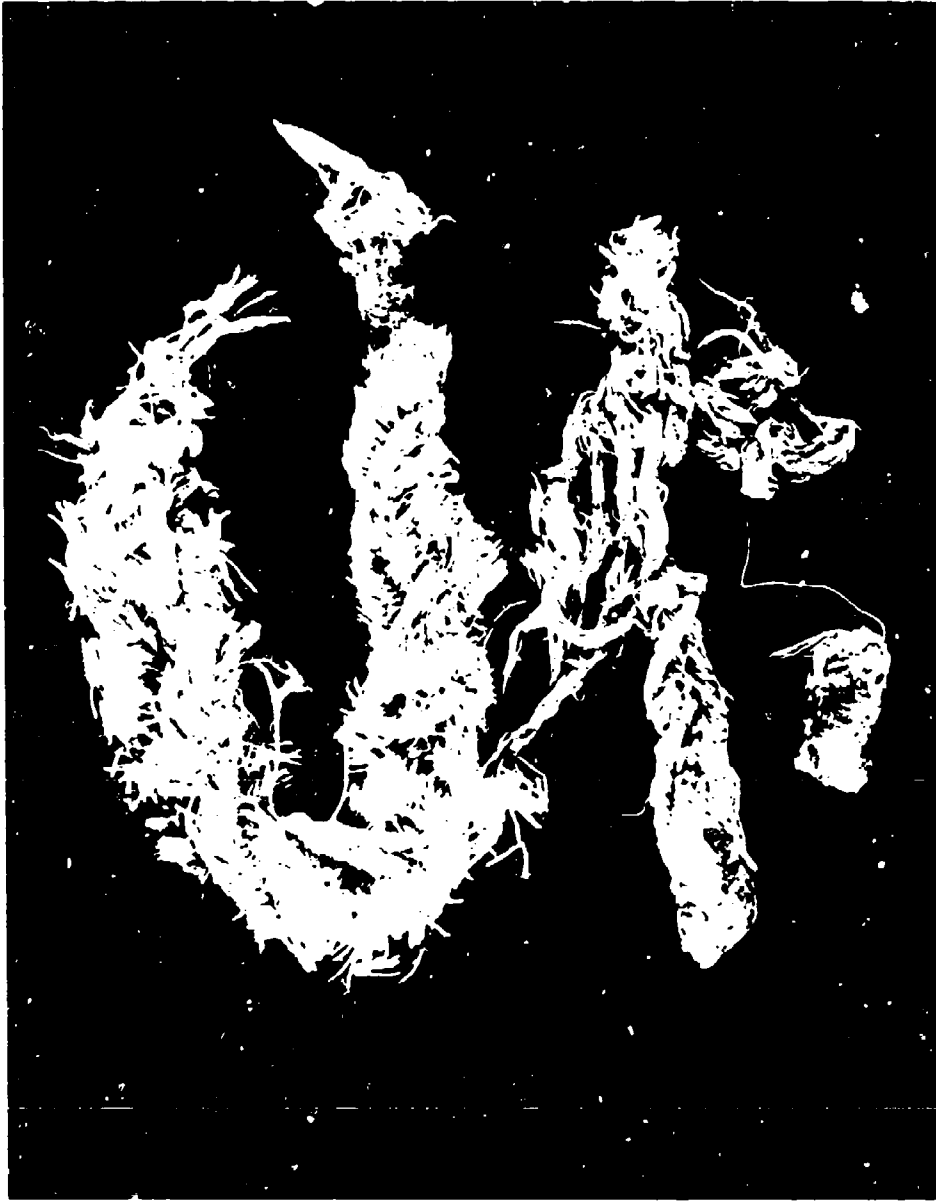
The recovered rope specimens (nylon, polyester, polypropylene, manila, and cotton) were covered with a layer of fine silt and some encrusting bryozoans. The fibers of manila and cotton ropes were deteriorated so severely by microorganisms that the fibers could easily be torn apart by one's fingers (Figure 6 and 7). The results of a tensile strength test conducted on the recovered synthetic ropes are presented in Table 2. The tensile strength of polyester, polypropylene, and nylon ropes decreased by 6.3, 9.5, and 19.7 percent, respectively. Data on tensile strength of manila and cotton ropes were not obtained since these had been severely deteriorated by biological activity. It is of interest to note that, although the tensile strength of polypropylene ropes had decreased when exposed in the bottom sediment, it had increased when such rope specimens were exposed in the deep-ocean environment (6000-ft depth).<sup>5</sup>

Figure 6. Cotton rope (1/2 inch diameter) fibers decayed by marine microorganisms after one year exposure.

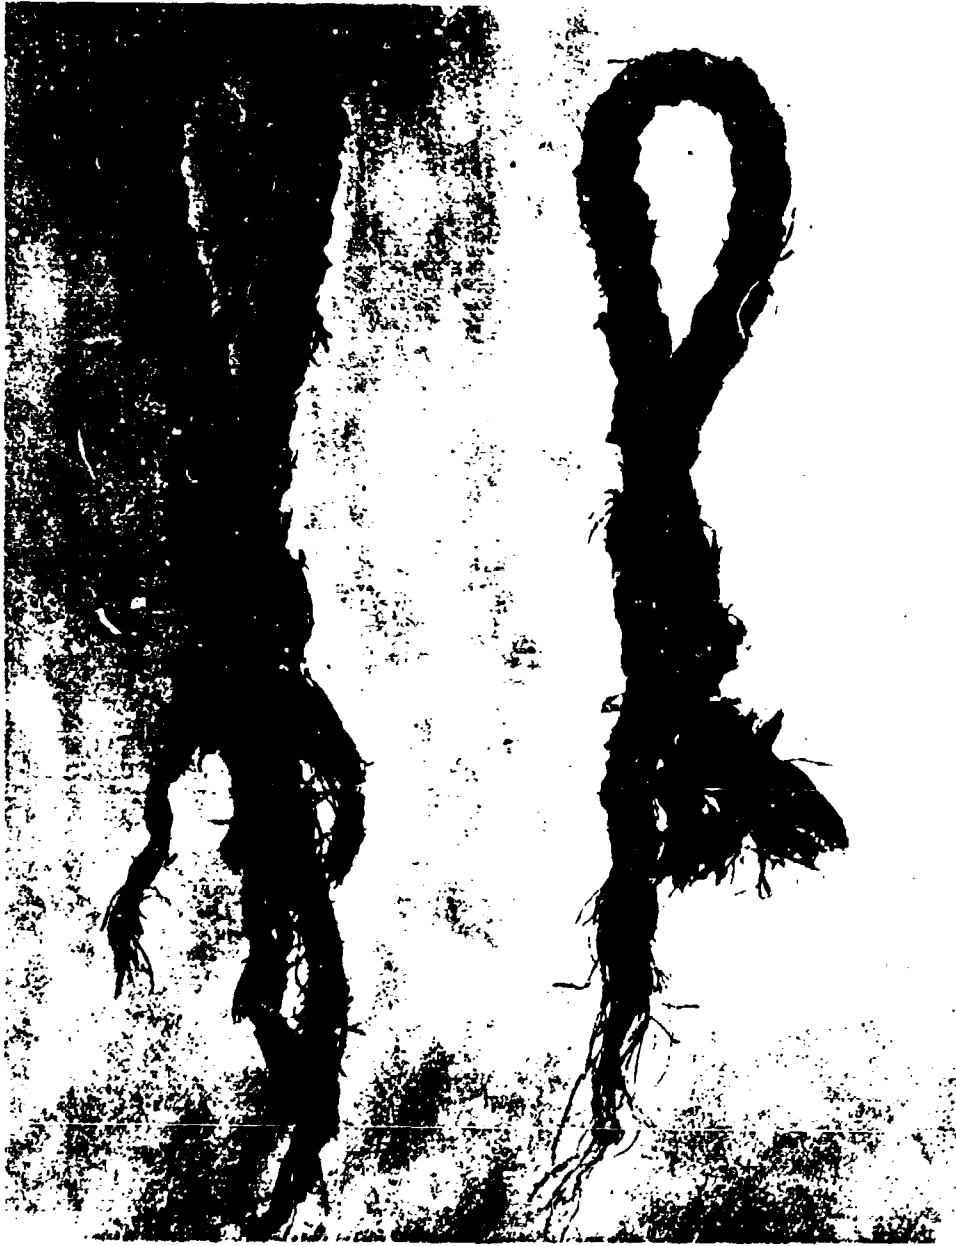
Figure 7. Manila rope (1/4 inch diameter) deteriorated by marine organisms after one year exposure.
